**COMPARATIVE PERFORMANCE OF STRUCTURAL LAYERS IN
PAVEMENT SYSTEMS**

**VOLUME I. DESIGN, CONSTRUCTION, AND BEHAVIOR
UNDER TRAFFIC OF PAVEMENT TEST SECTIONS**

ARMY ENGINEER WATERWAYS EXPERIMENT STATION

**PREPARED FOR
FEDERAL AVIATION ADMINISTRATION**

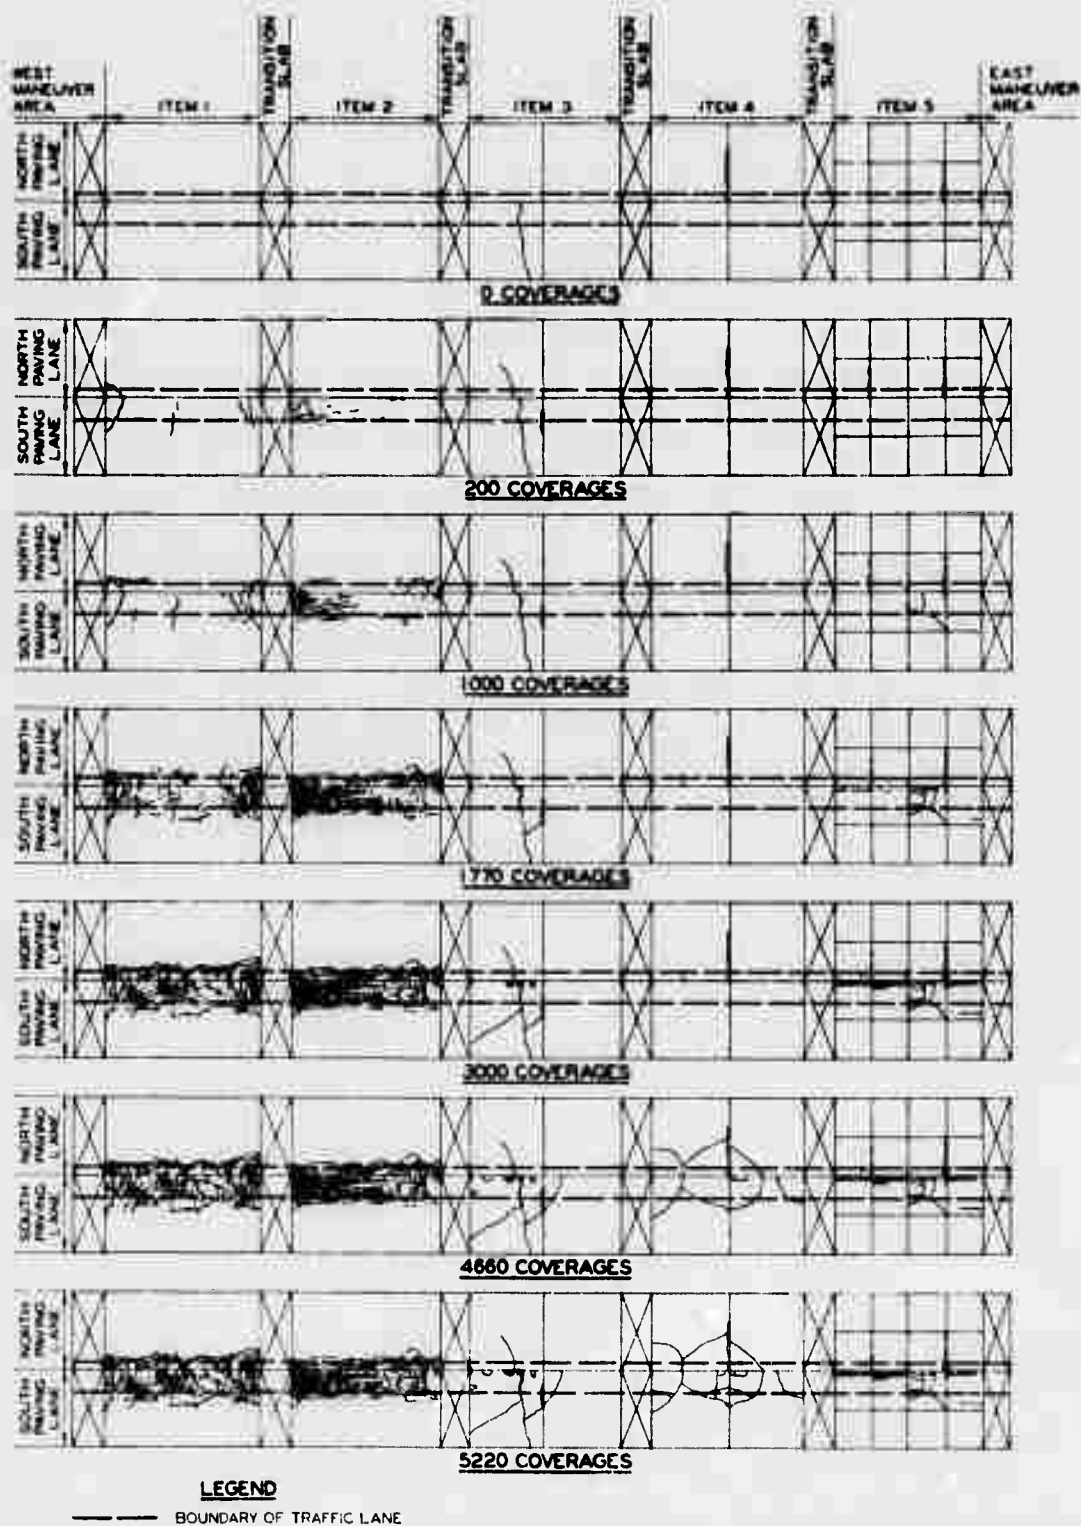
Figure A5. Crack development in lane 1, rigid pavement test section

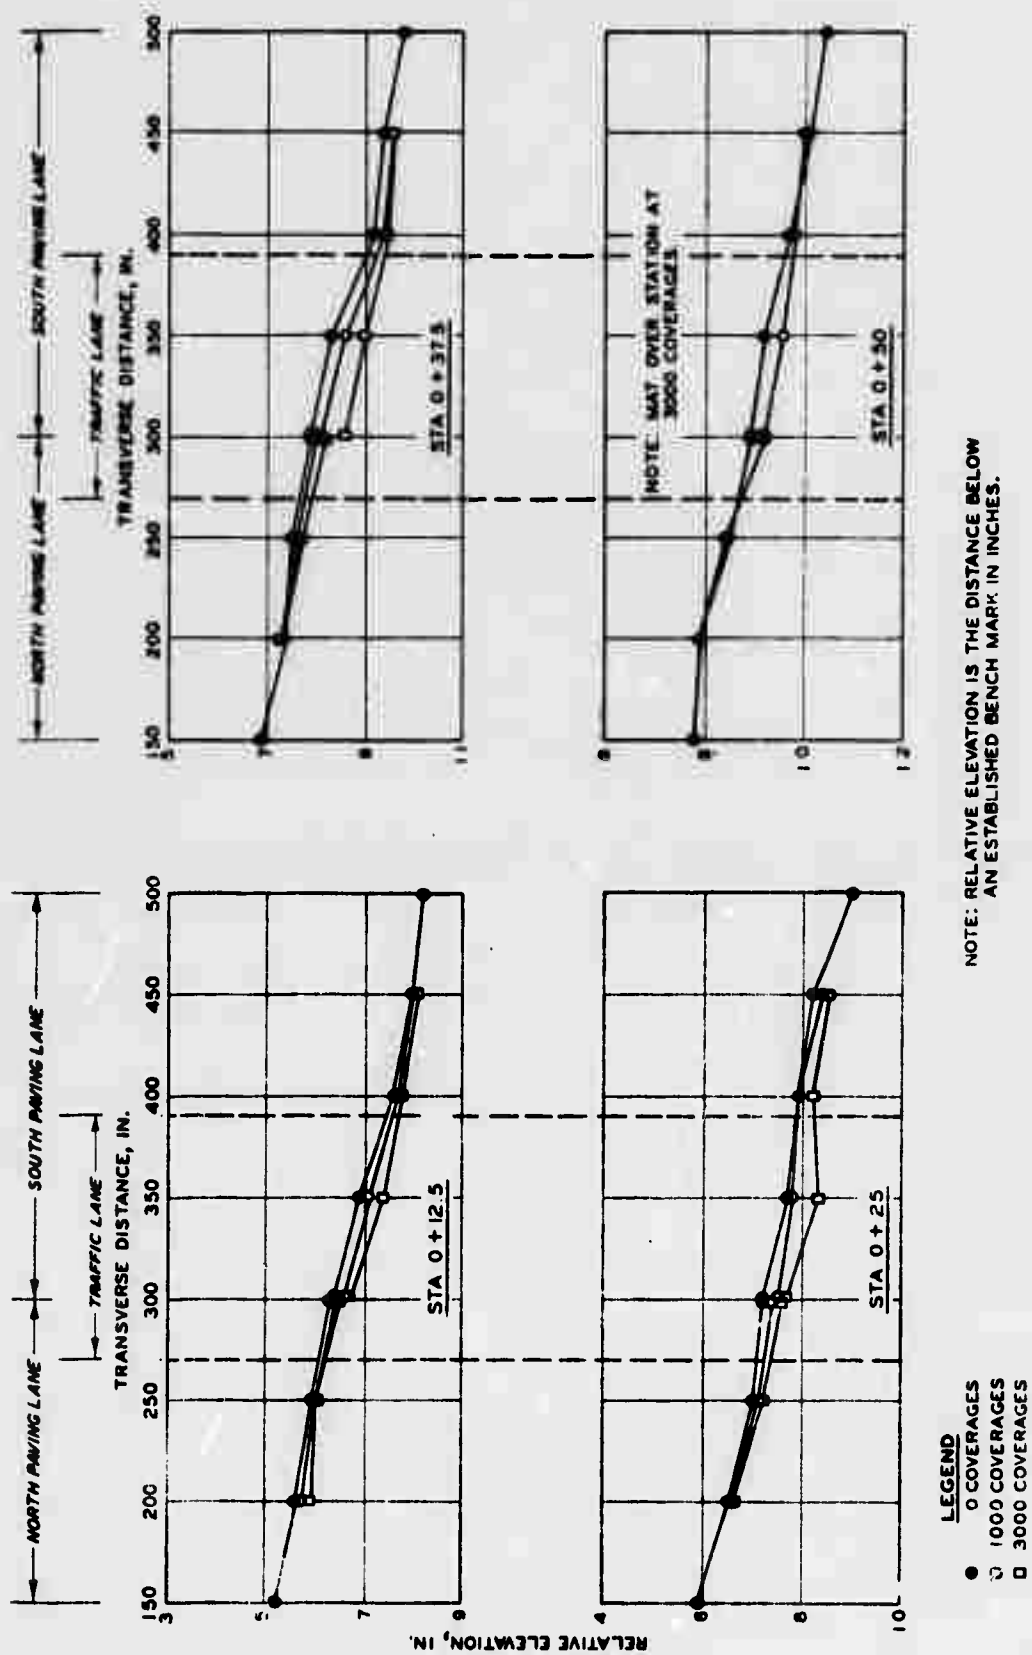
Figure A6. Surface deformation in item 1, lane 1, rigid pavement test section

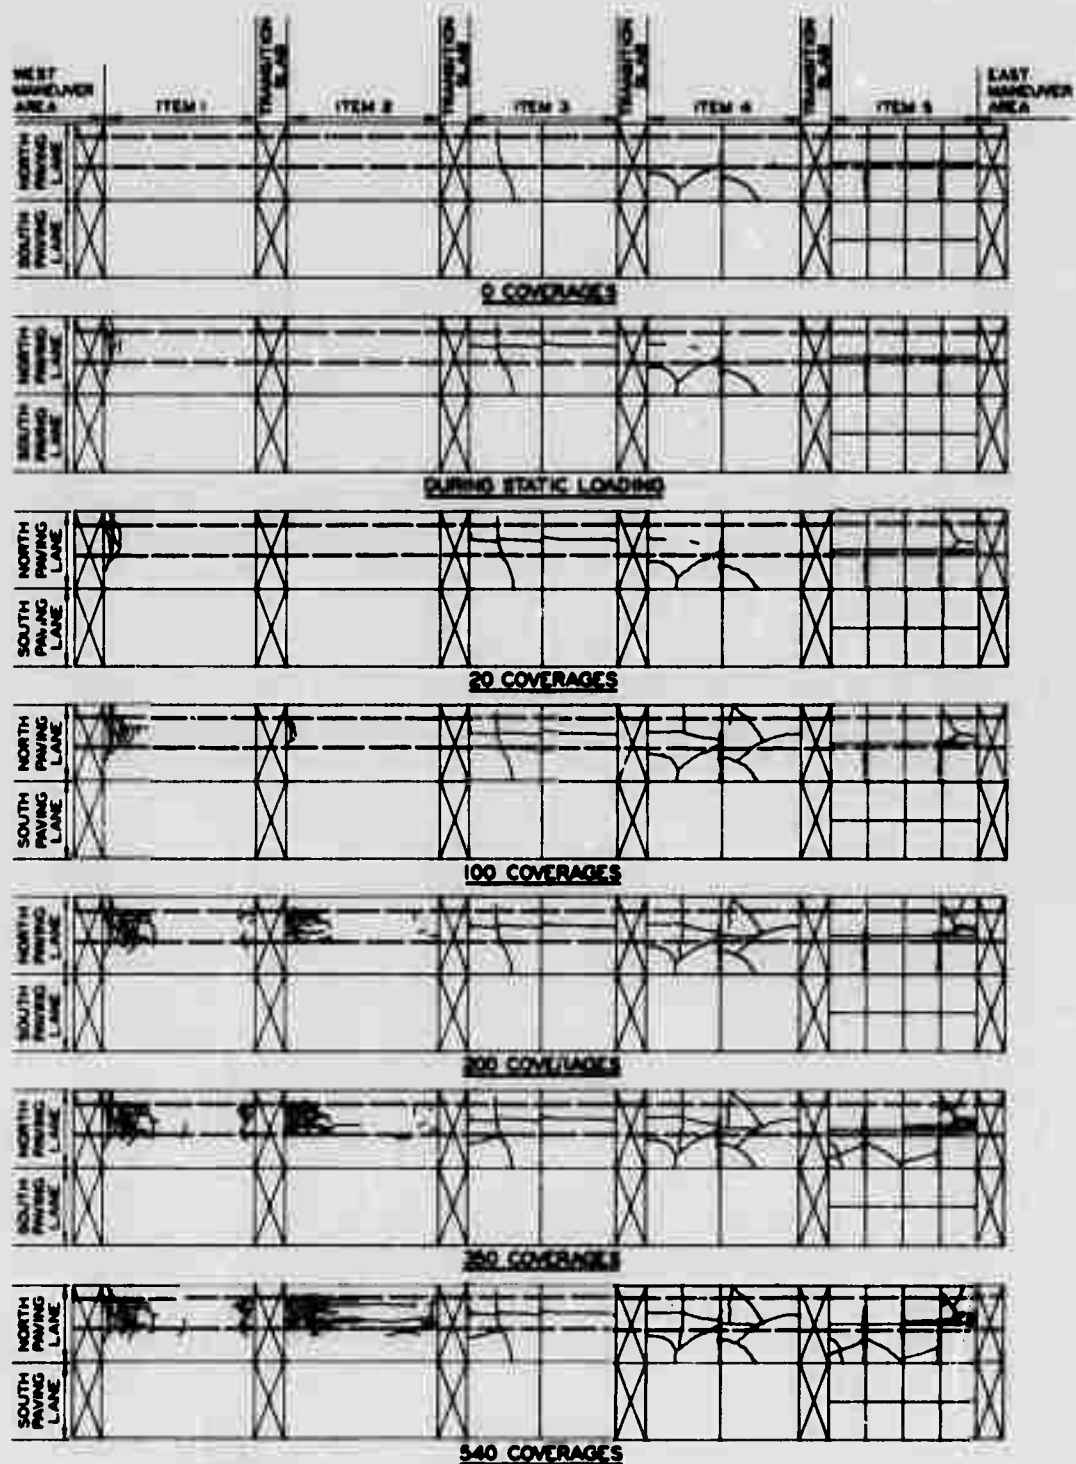
Figure A32. Crack development in lane 2, rigid pavement test section

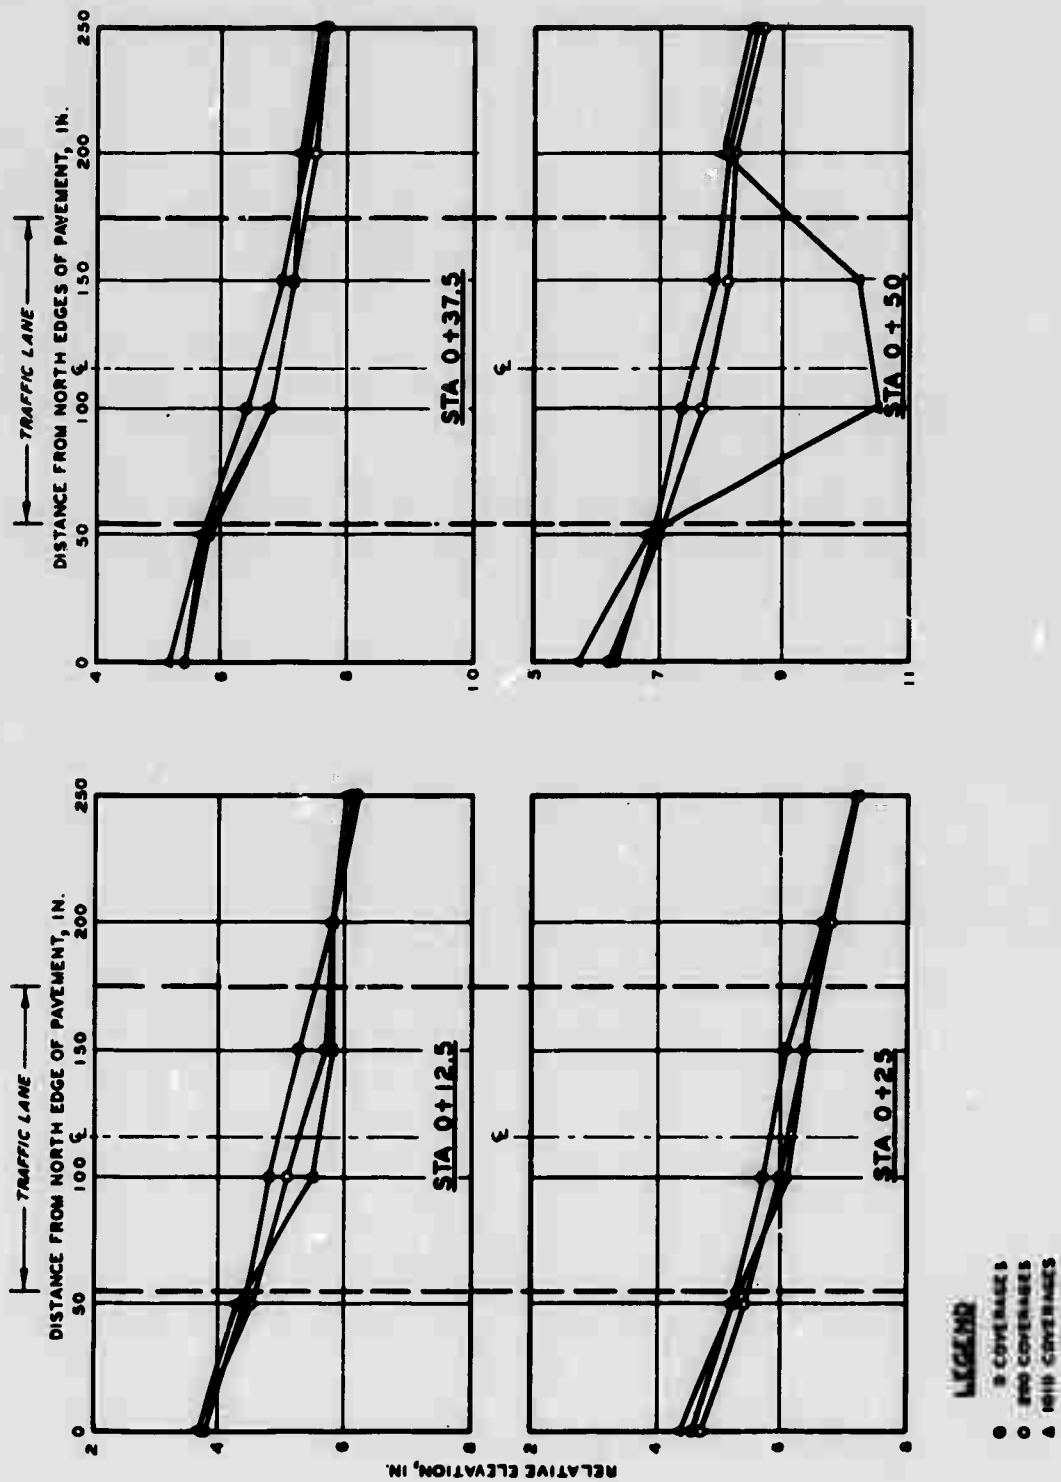
Figure A35. Surface deformation in item 1, lane 2, rigid pavement test section

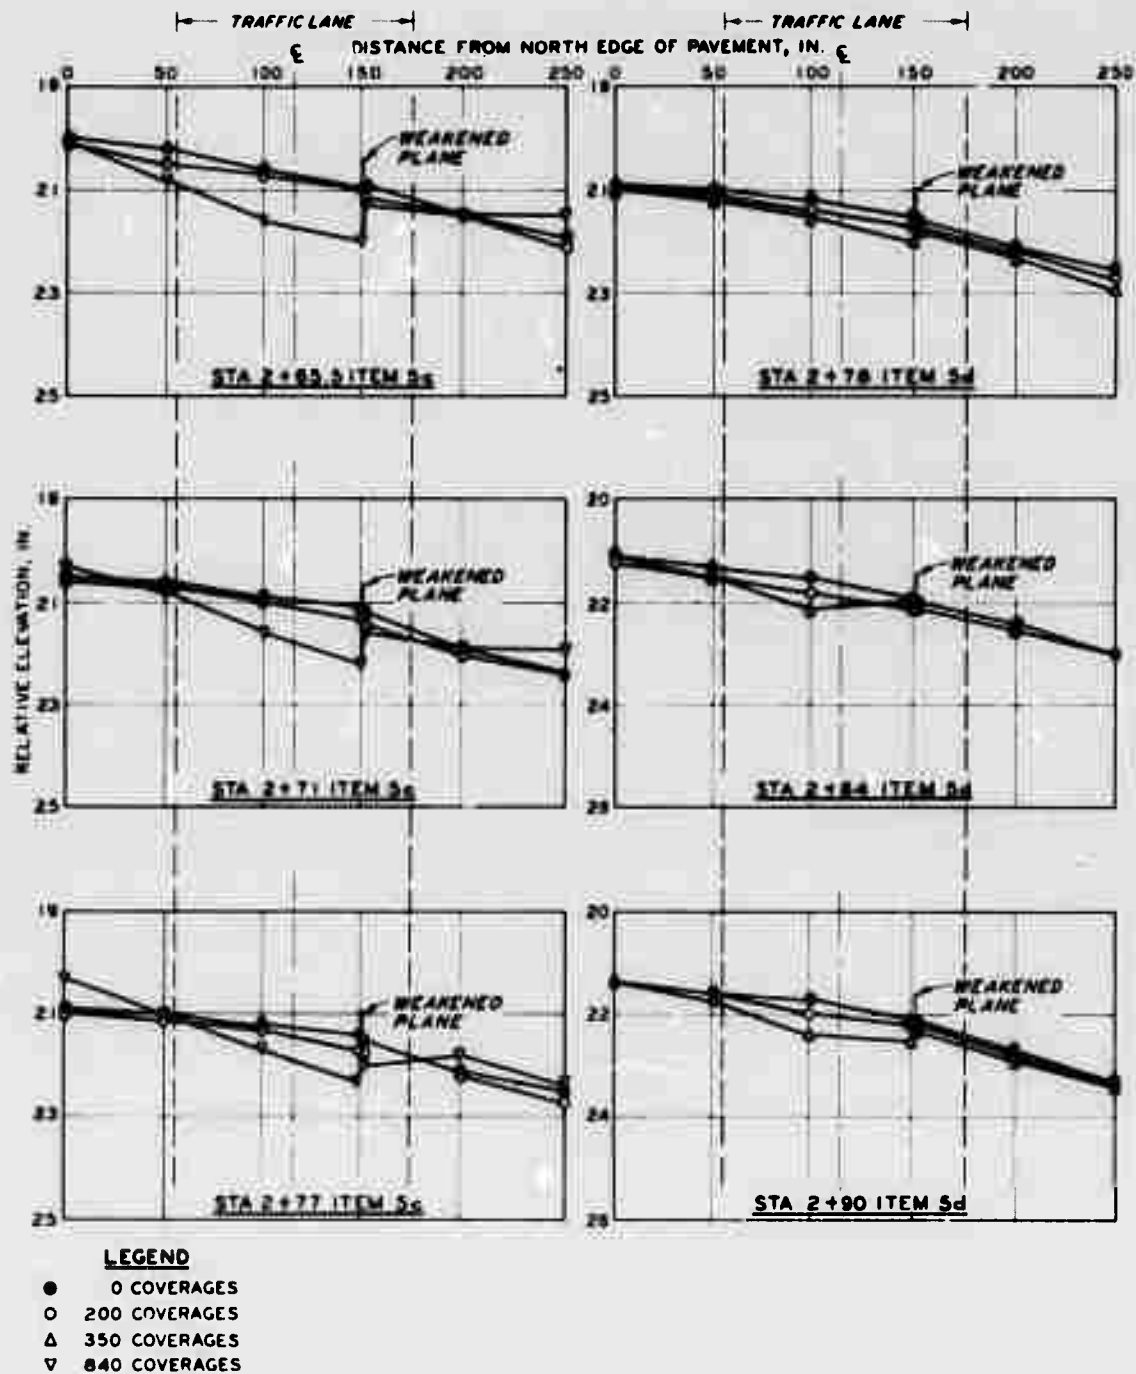
Figure A55. Surface deformation in subitems 5c and d, lane 2, rigid pavement test section

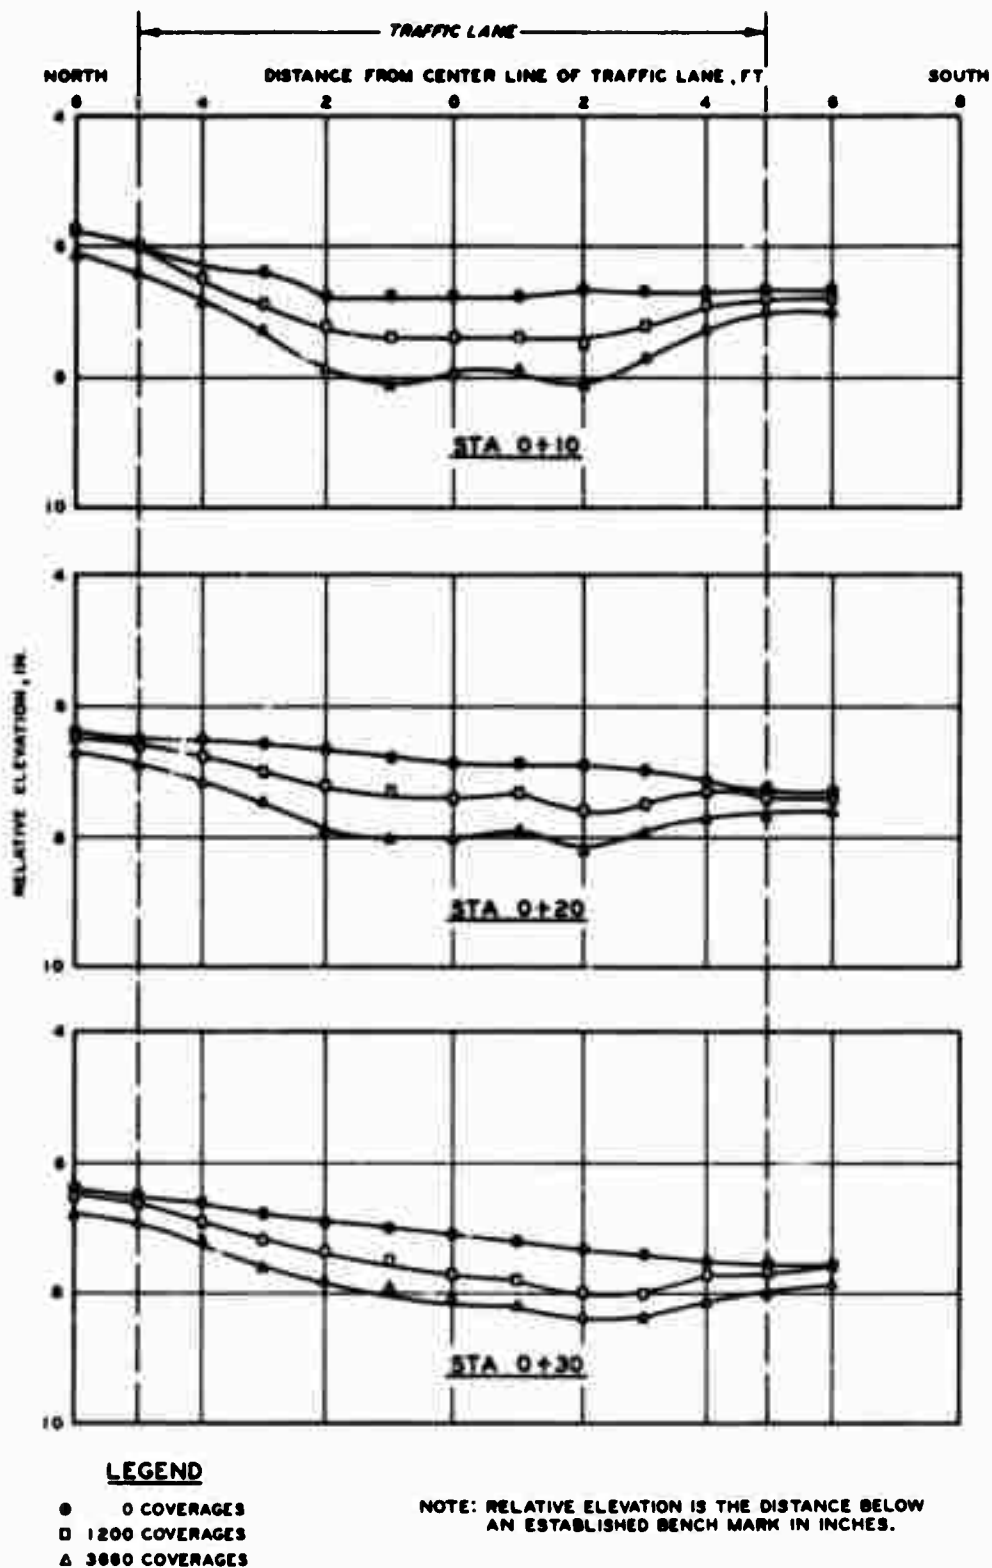
Figure B18. Surface deformation in item 1, lane 1, flexible pavement test section

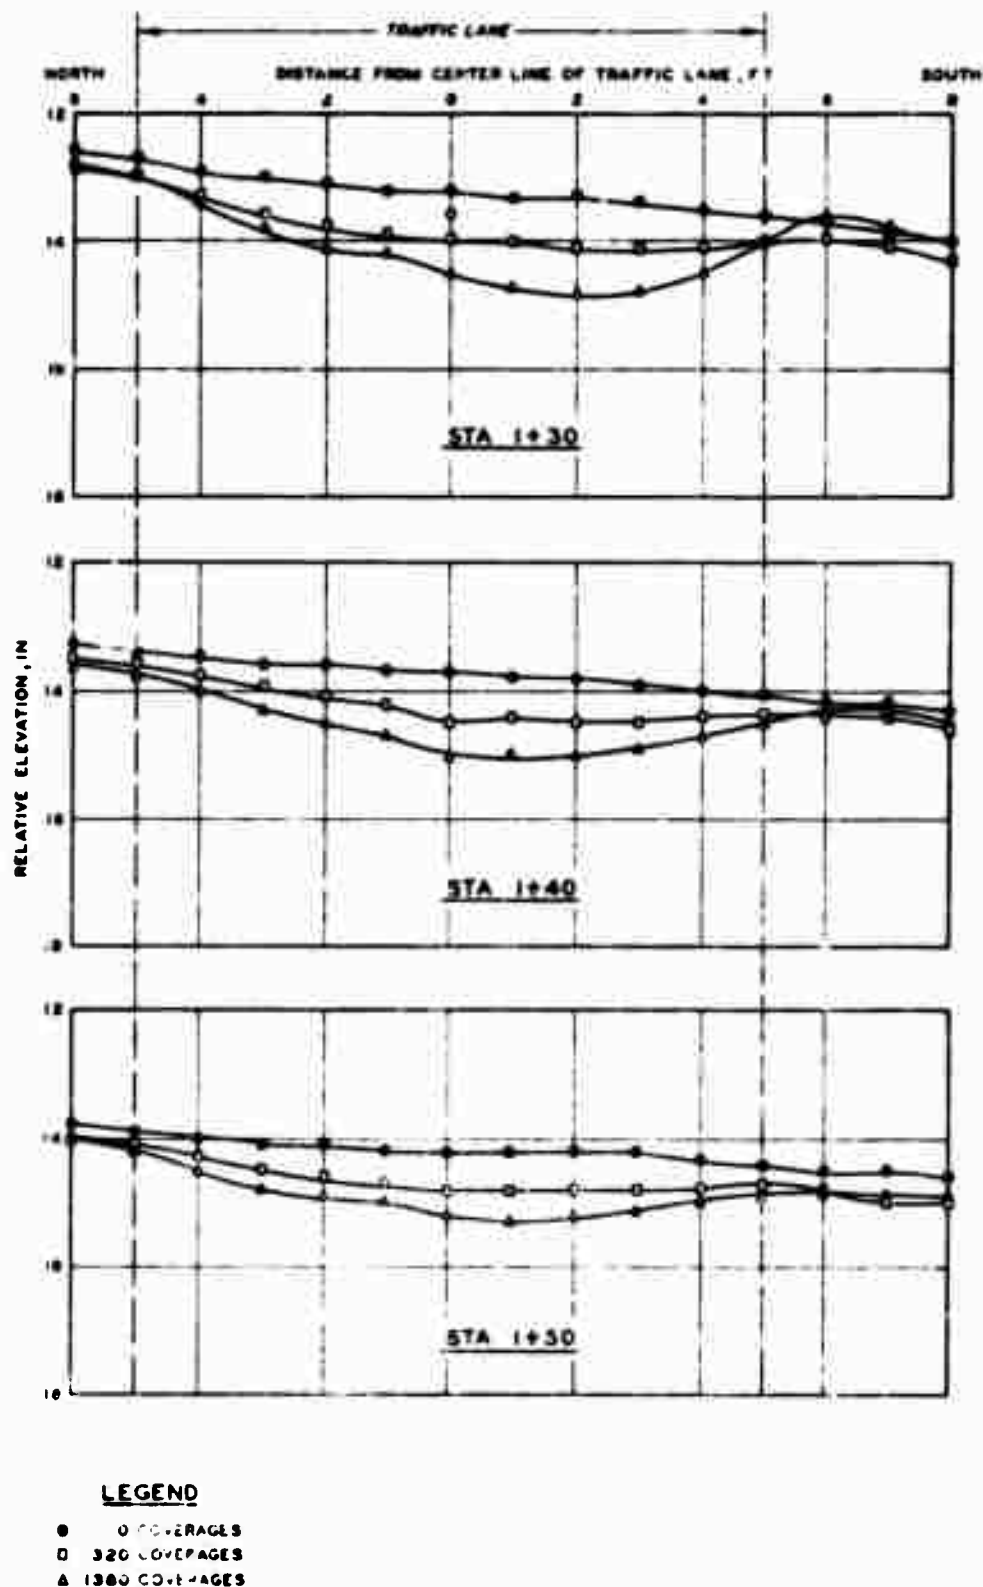
Figure B21. Surface deformation in item 4, lane 1, flexible pavement test section

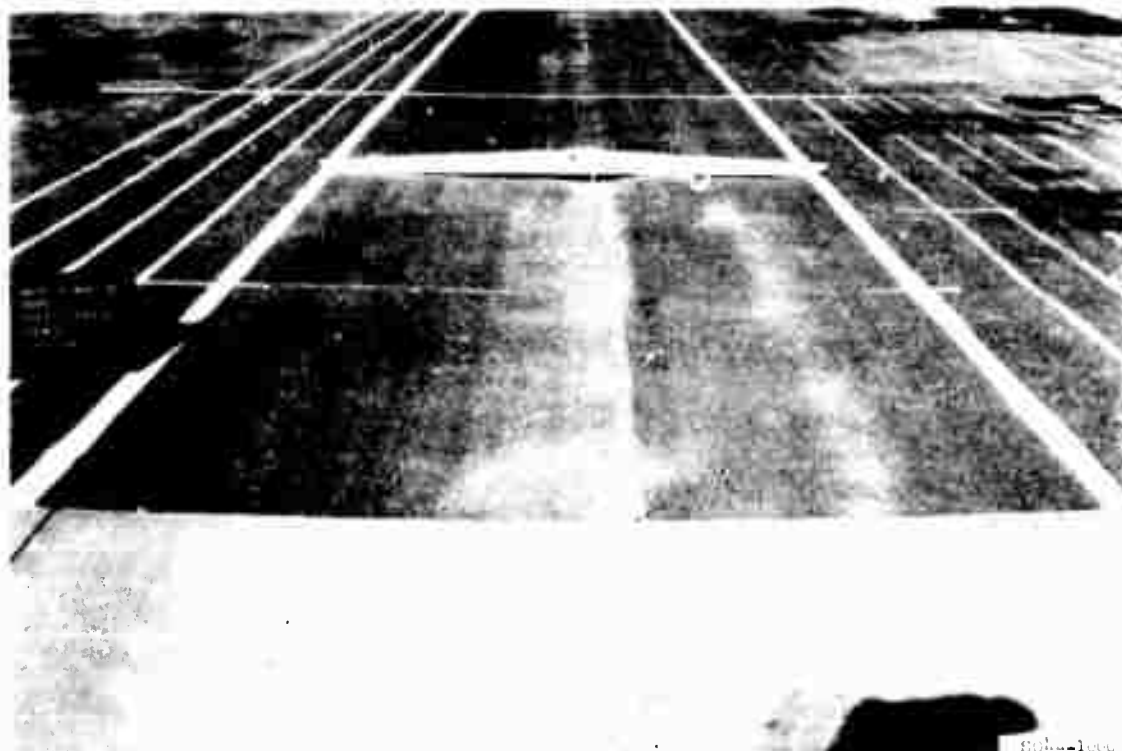
Figure B35. Cracking and deformation in item 4, lane 2, flexible pavement test section, at failure after 120 coverages of 240-kip twin-tandem assembly

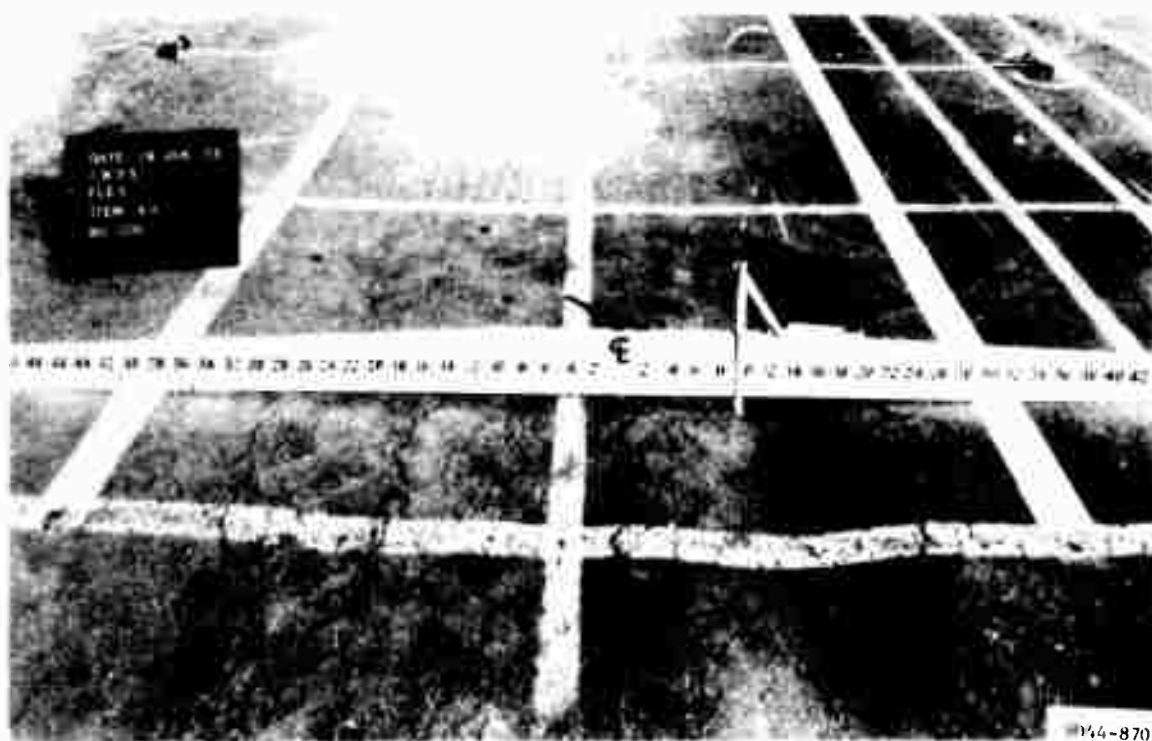
Figure B52. Cracking in subitem 4a, lane 3, flexible pavement test section, after 80 coverages of 50-kip single-wheel assembly

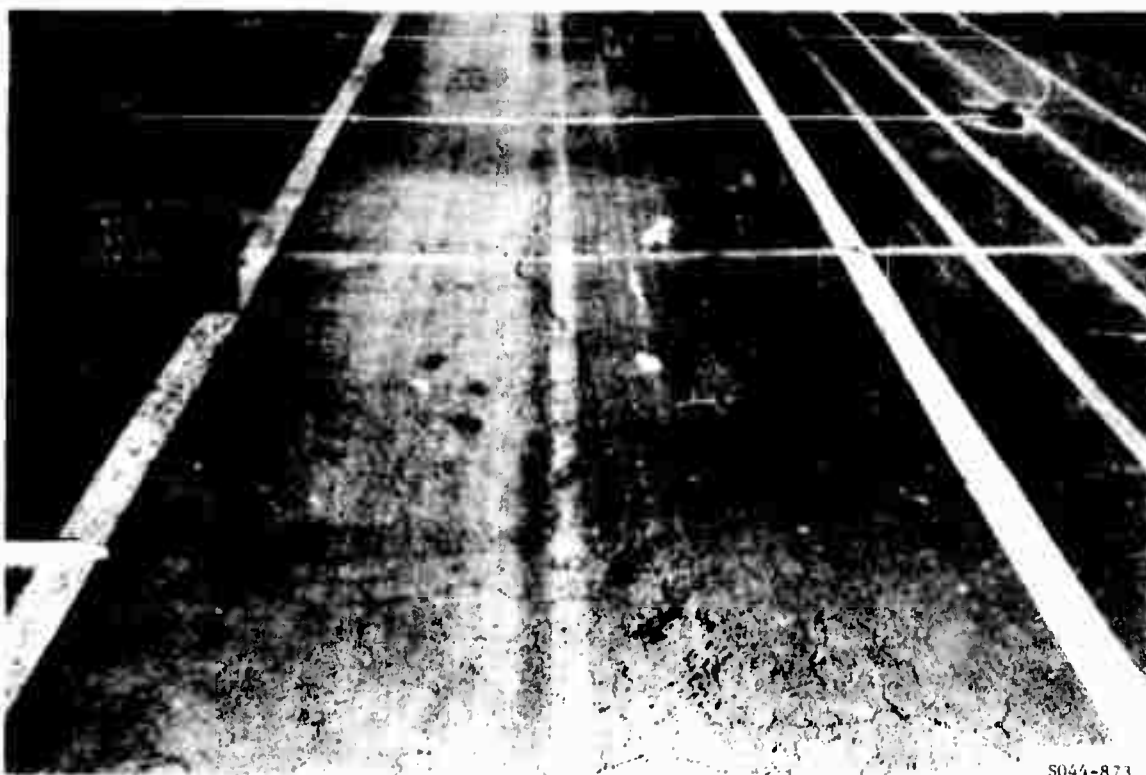
Figure B54. Cracking and deformation in subitem 4b, lane 3, flexible pavement test section, at failure after 170 coverages of 50-kip single-wheel assembly

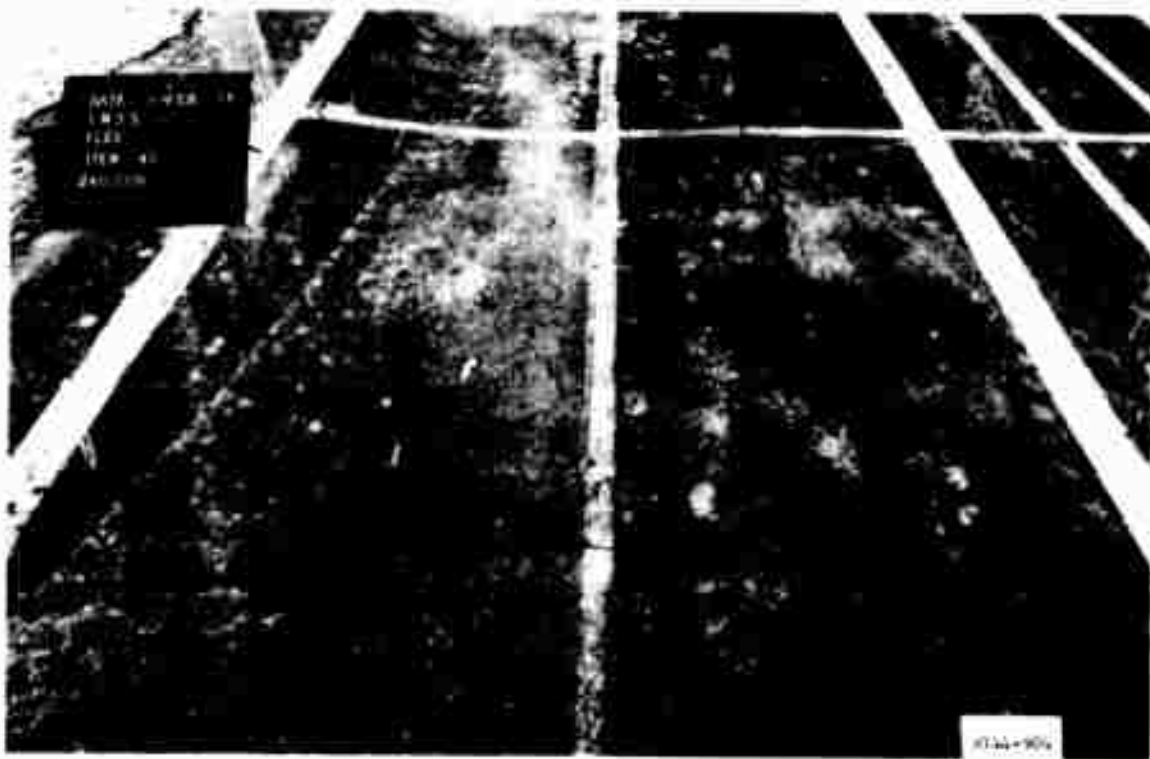
Figure B56. Cracking in subitem 4c, lane 3, flexible pavement test section, at failure after 240 coverages of 50-kip single-wheel assembly

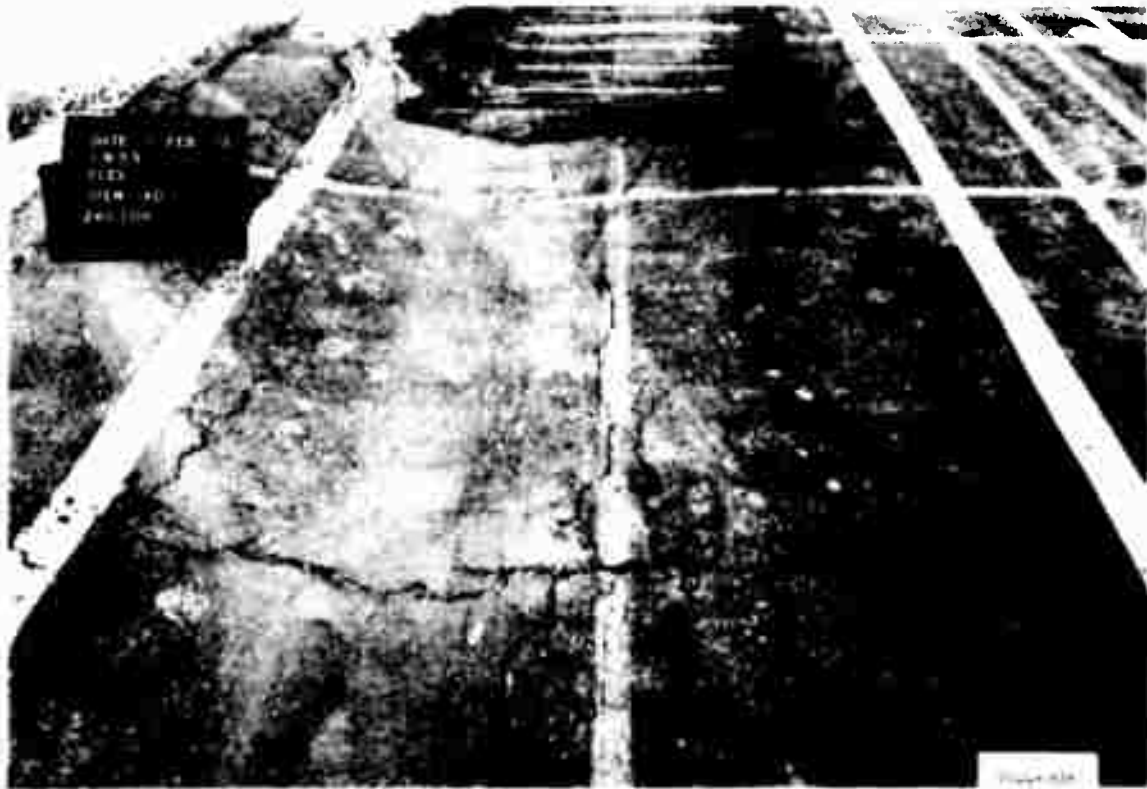
Figure B59. Cracking in subitem 4d, lane 3, flexible pavement test section, at failure after 240 coverages of 50-kip single-wheel assembly

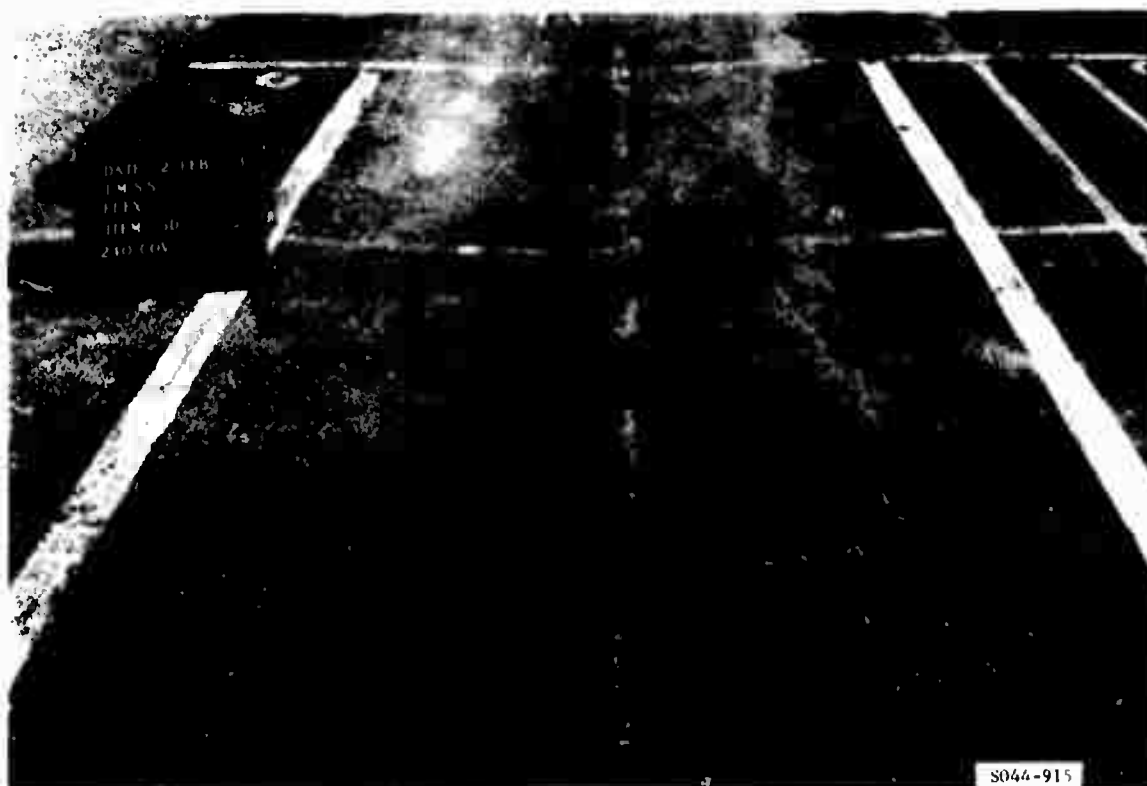
Figure B67. Cracking in subitem 5d, lane 3, flexible pavement test section, at failure after 240 coverages

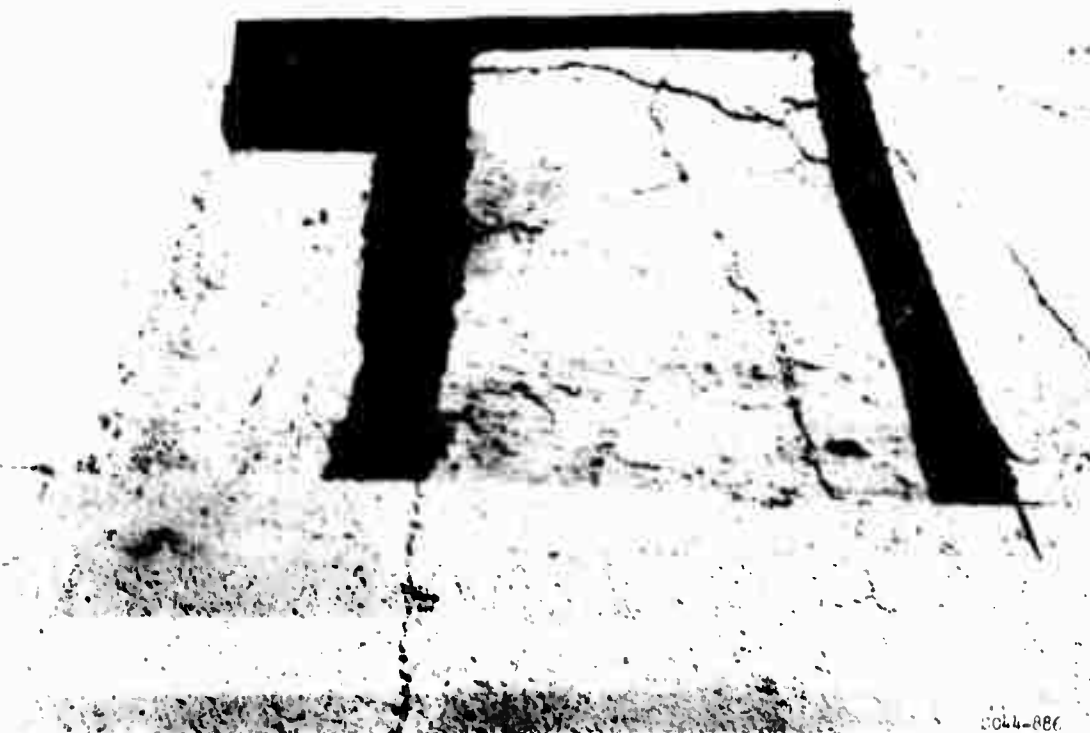
Figure B80. Cracks in lightweight concrete in subitems 4d and 5a, lane 3, flexible pavement test section, after 170 coverages of 50-kip load
